# **New Insights into Whole Building Performance from the Christchurch Natural Laboratory**

**Presentation to UACEER 2012 Earthquake Engineering Research Symposium, by G Charles Clifton**

**28 November 2012**

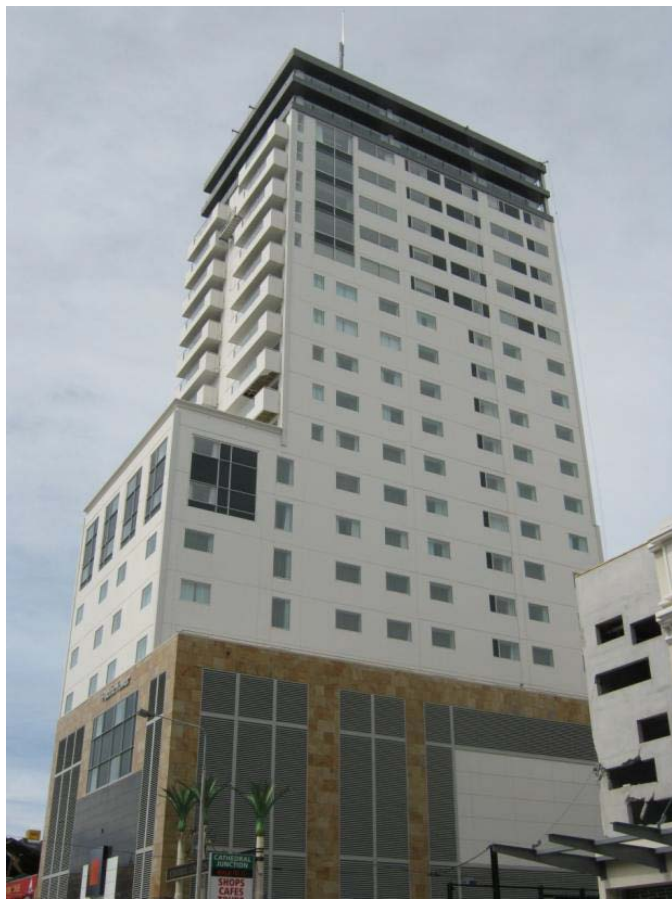
# Case Study: Pacific Tower

**22 storey mixed EBF and MRF, composite floors,  
transfer diaphragms levels 2, 6, 11, 20**

- Building over 2x stiffer than model
- Building has effectively self centred:
  - 60 mm out of plumb midheight
  - 30 mm out of plumb at top
  - under 0.1% residual deflection most floors
- Repairs required
  - Significant inelastic demand levels 2 to 7; most active links in those levels will be replaced (42 in total)
  - Some active link steel does not meet the new specification which post-dates this building; if had less repair required
  - Cracking in composite floors; all cracks over 0.5mm wide being epoxy grouted
  - Requires realignment of lift guide rails
  - Plan to reopen February 2013

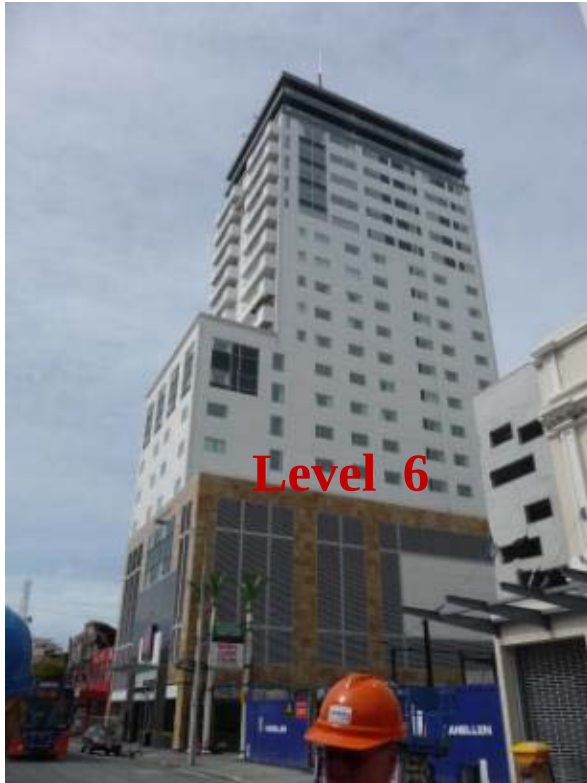
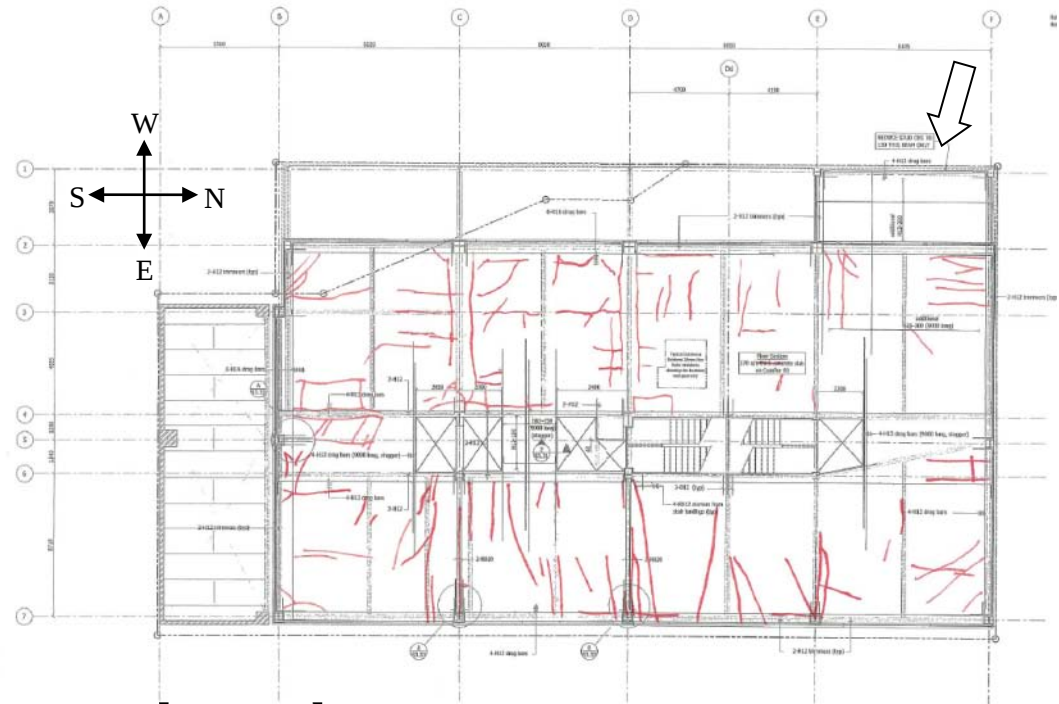
# Pacific Tower Floor Slab Cracking: Level 6

Floor cracking shows:

- Evidence of torsional response?
- Slab elongation NS  $\approx 3-4$  mm; EW 1-2 mm
- Maybe cracking due to vertical motion
- Minimal damage around EBFs

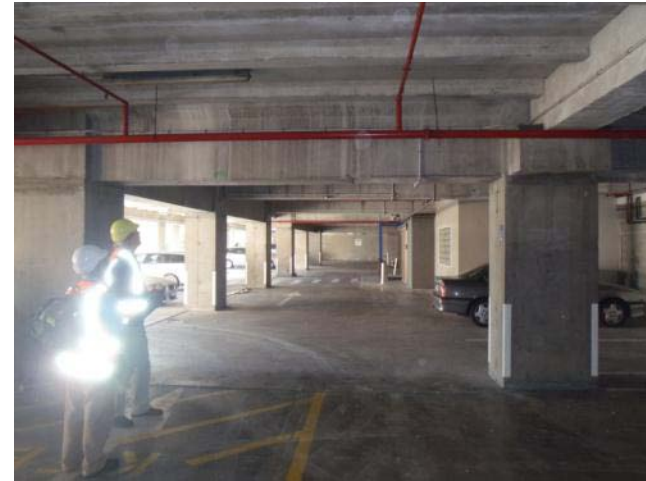
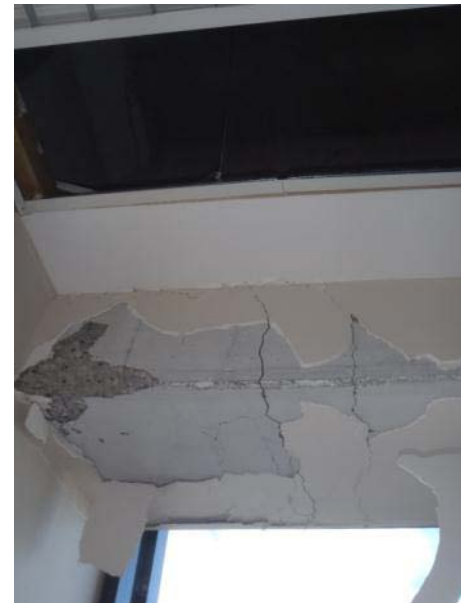
# Performance of Modern Concrete Moment Resisting Frames

- Capacity design procedure has worked as expected
- No visible damage to columns or beam column joints of MRCFs
- Problem is plastic hinge cracking in beams:
  - Expect large number of small cracks
  - Seen small number large cracks
  - Loss of reinforcement strain?
  - Threshold for leave in place?
  - Strategy for repair?

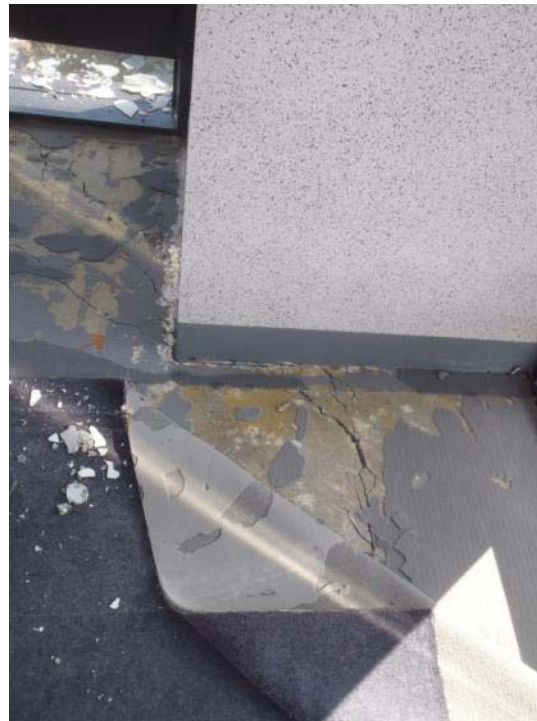
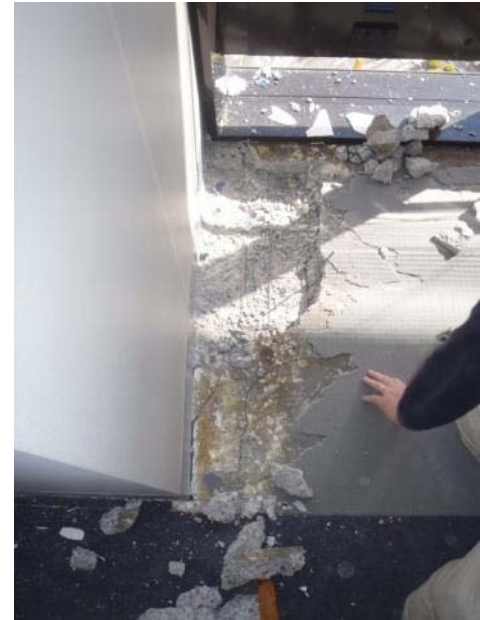
# Floor Slab Response in Reinforced Concrete Frames with Precast Floors

- Floors pulling away from frames, shear walls
- Beam elongation in frames
- Reinforcing bar strains and fracture
- Enhanced torsional response
- How to repair??

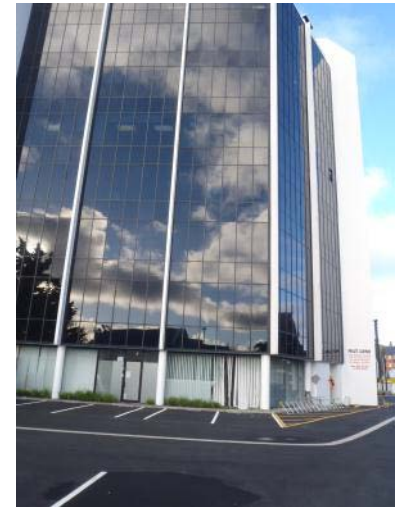
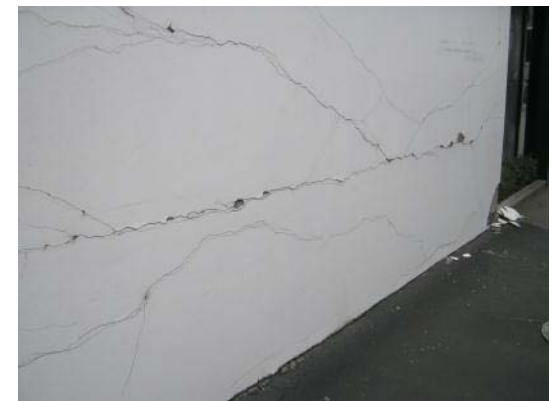
# Shear Wall Performance

- Single major transverse crack in many cases
- Fractured rebar
- Transverse splitting of walls and compression failure
- Progressive deterioration in successive earthquakes
- Reasons for failures to be determined
  - evidence of high compression along full length of walls
- How to repair?

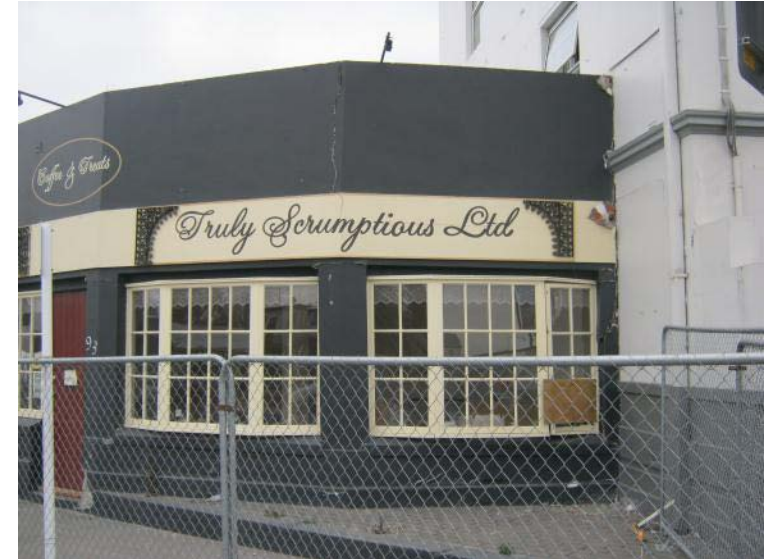
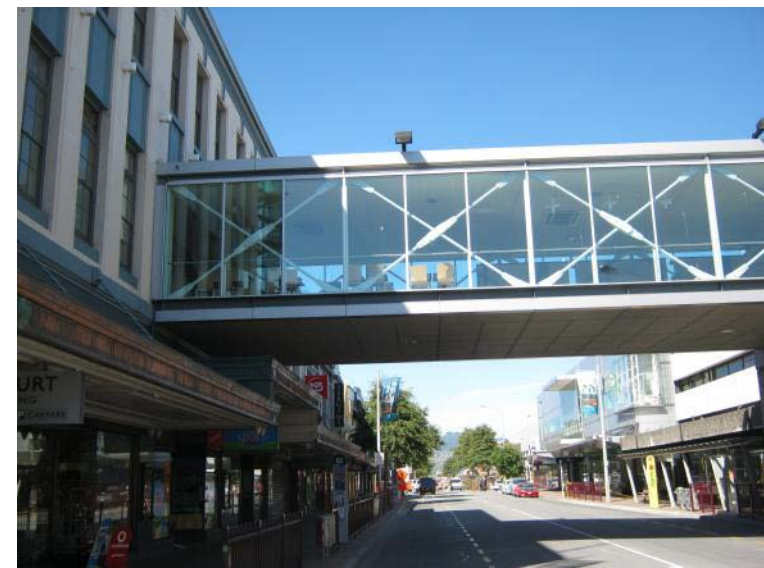
# Pounding of Buildings

- Increasingly significant cause of damage in older buildings
- Not significant in modern buildings

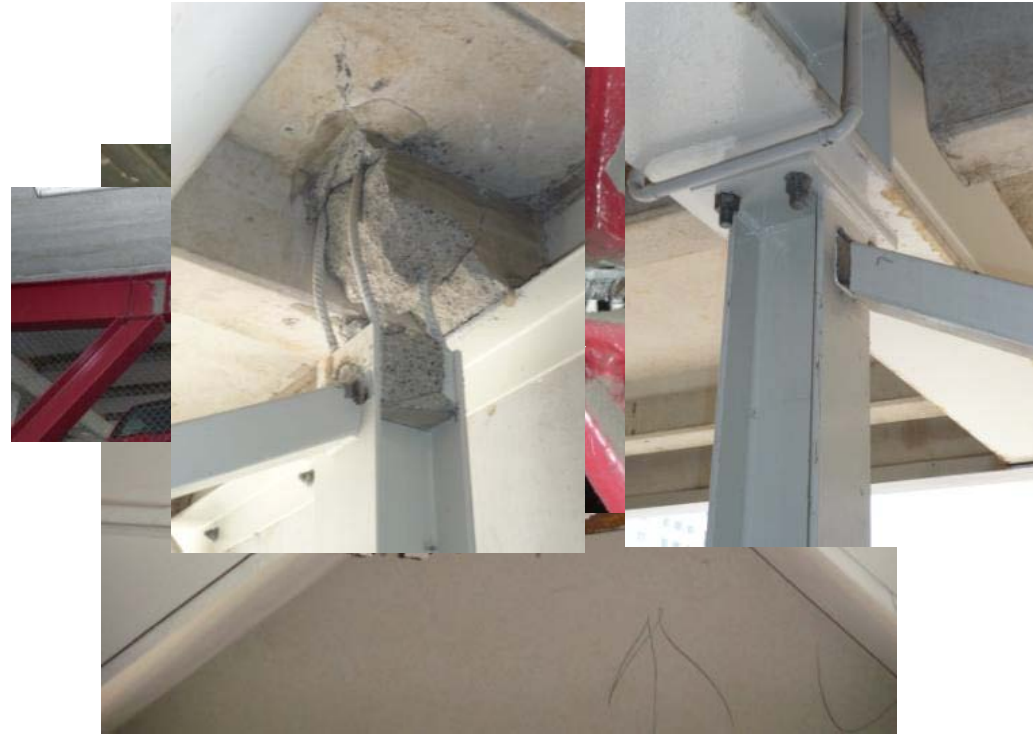
# Effects of Poor Detailing and Below Specification Materials

Poor details or below specification material performed badly, some examples shown:

- Braces not lined up with stiffeners
- Frames not connected into the floors
- Inadequate welds
- Steel with very low notch toughness

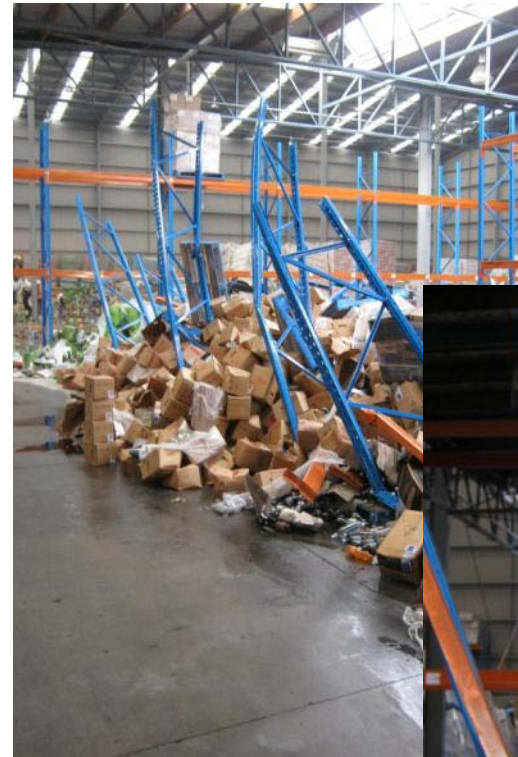
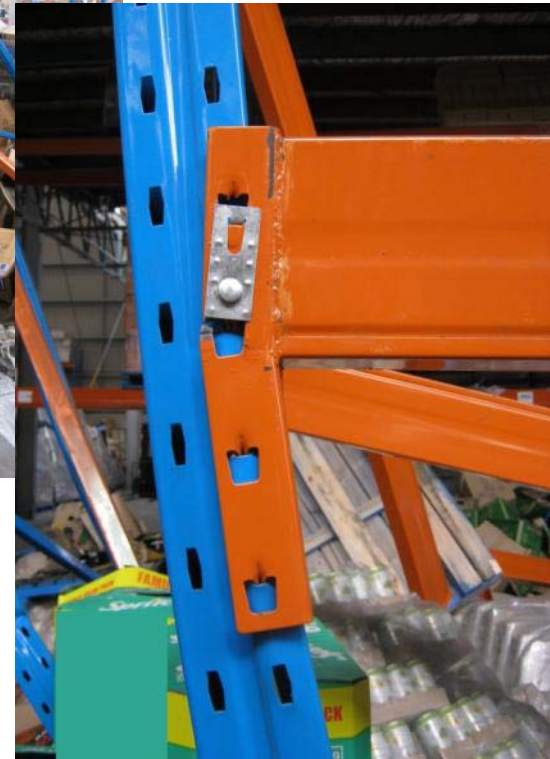
# Failure Modes: Down-aisle direction

- Yielding of the beam to column connection
- Column crippling followed by soft storey

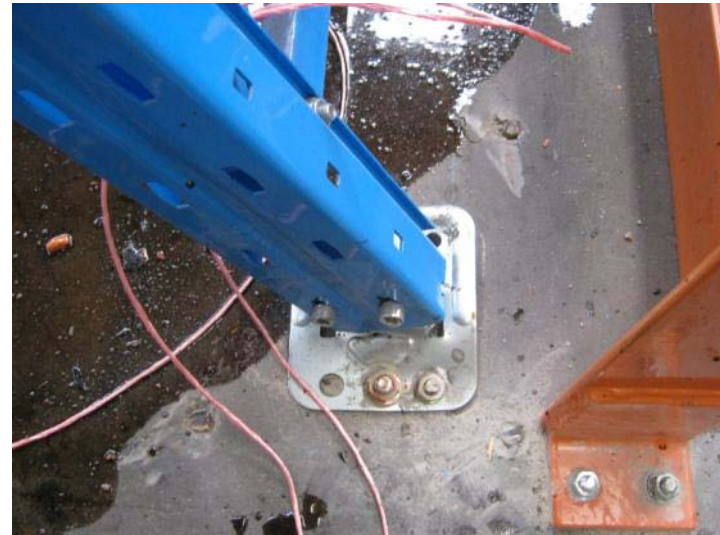
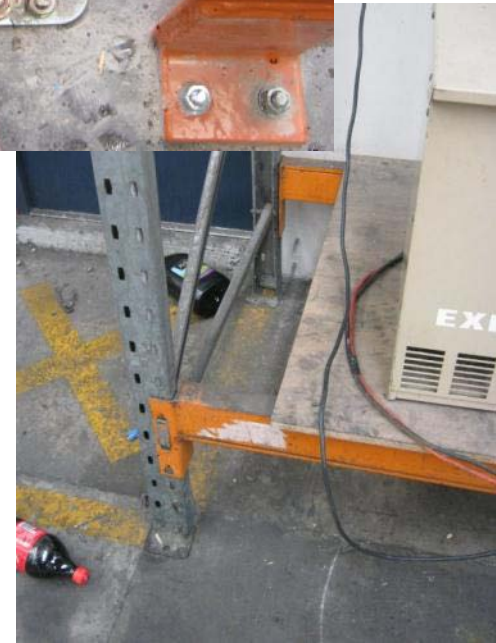
# Failure Modes: Transverse direction

- Fracture of baseplate
- Pull-out of baseplate from slab

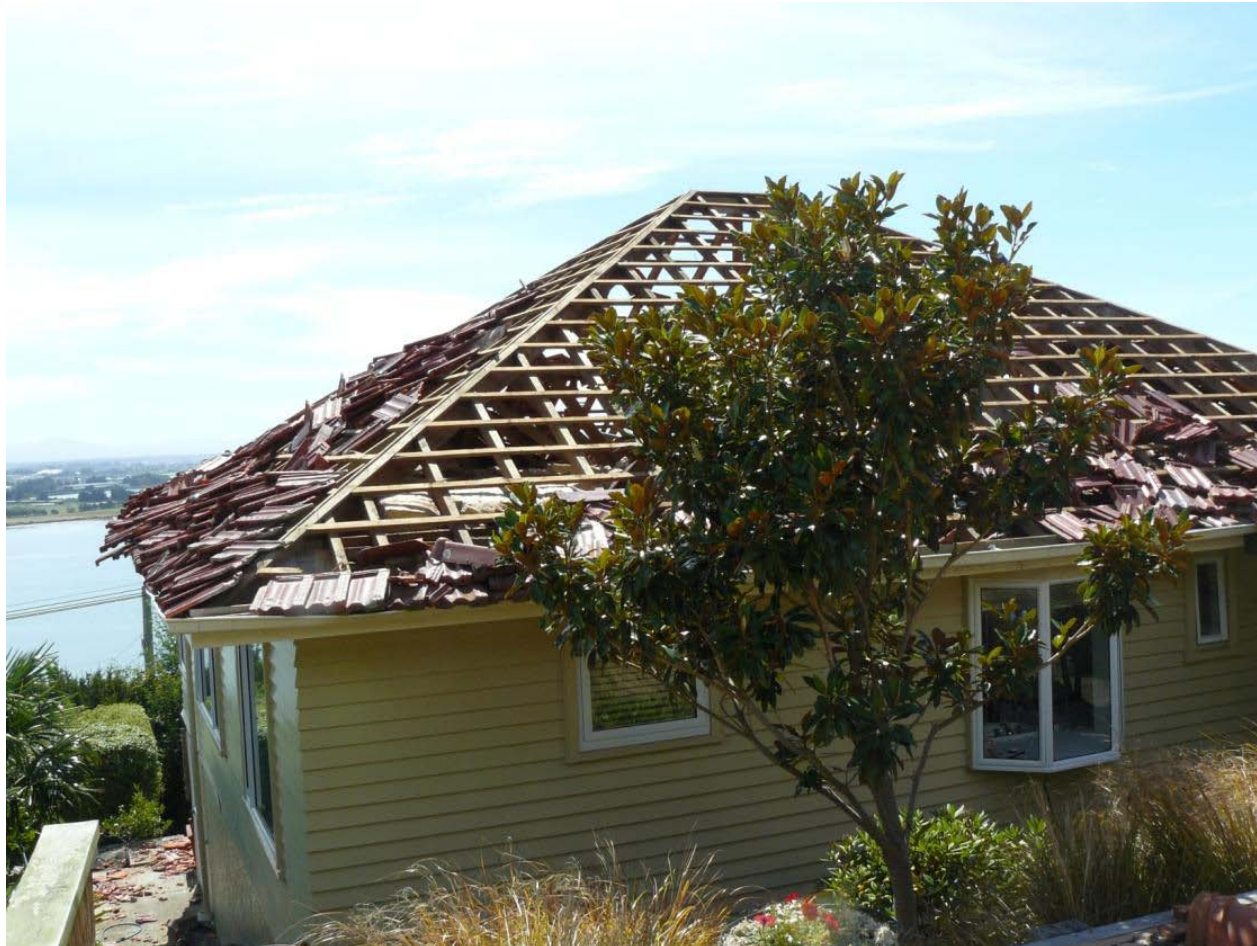
# Concrete Tiled Roofs

Roof  
shaken off

Chimneys  
through  
roofs

Timber  
house  
structurally  
safe

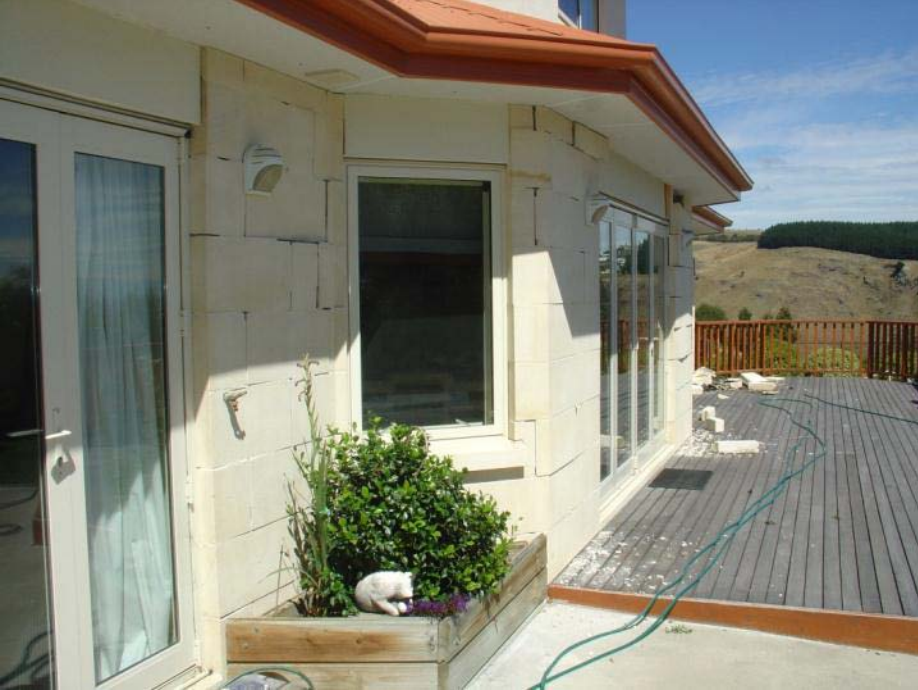
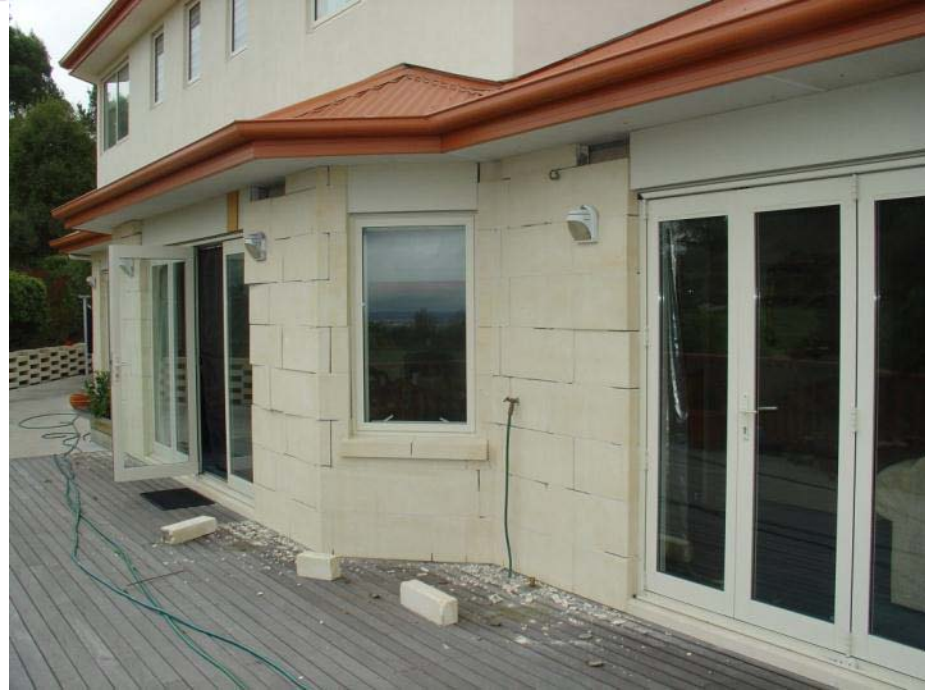
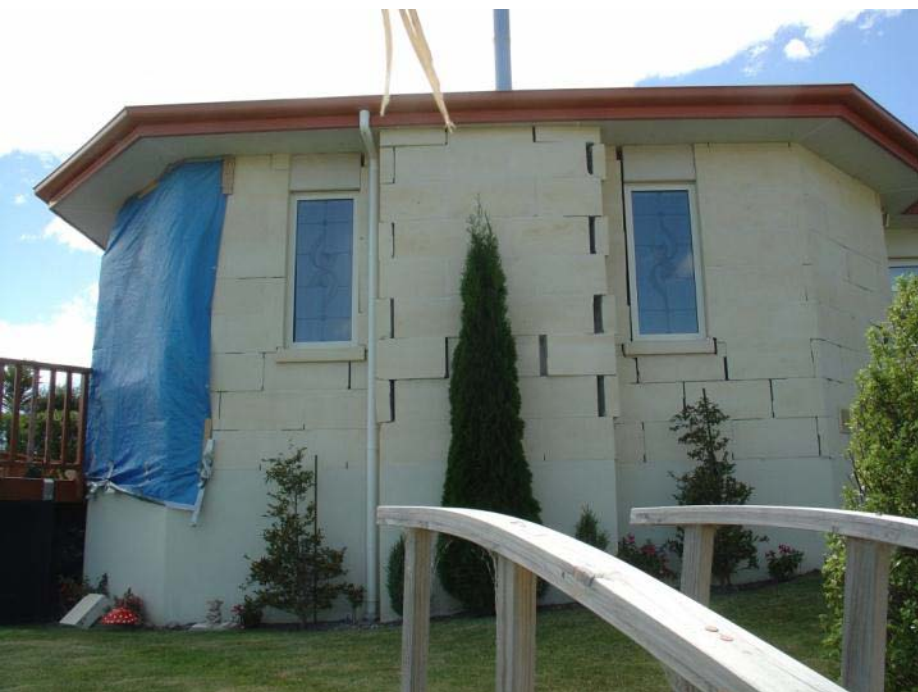
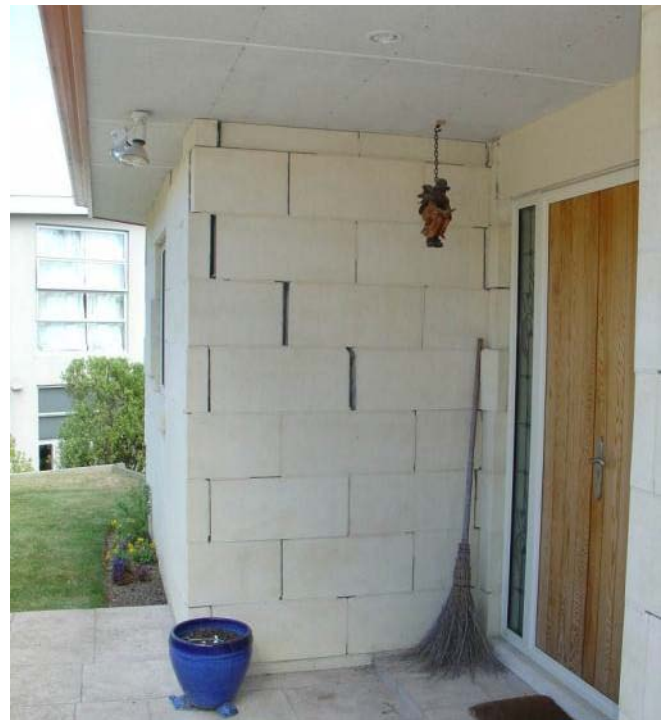
## 2 Storey House on 22 Feb Fault Line

- $PGA_H$  and  $PGA_V = 1.8g$
- Oamaru stone veneer damaged
  - Stones slid on mortar lines
  - Up to 8 stones dislodged
- Minor cracking internal gypsum board linings in places
  - Longest 1m crack
- Minor misalignment of one internal wall
  - Foundation bolt may have partially pulled out
- Client is very pleased
  - His house is repairable; stone veneer only significant damage
  - Similar houses close by destroyed
