Seismic Assessment and Improvement of Napier's Art Deco Buildings

UACEER 2012 Earthquake Engineering Research Symposium

Kevin Walsh and
Jason Ingham

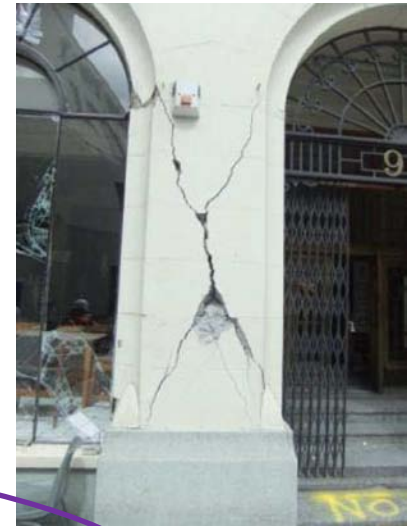
Vertical irregularities (fairly minimal)

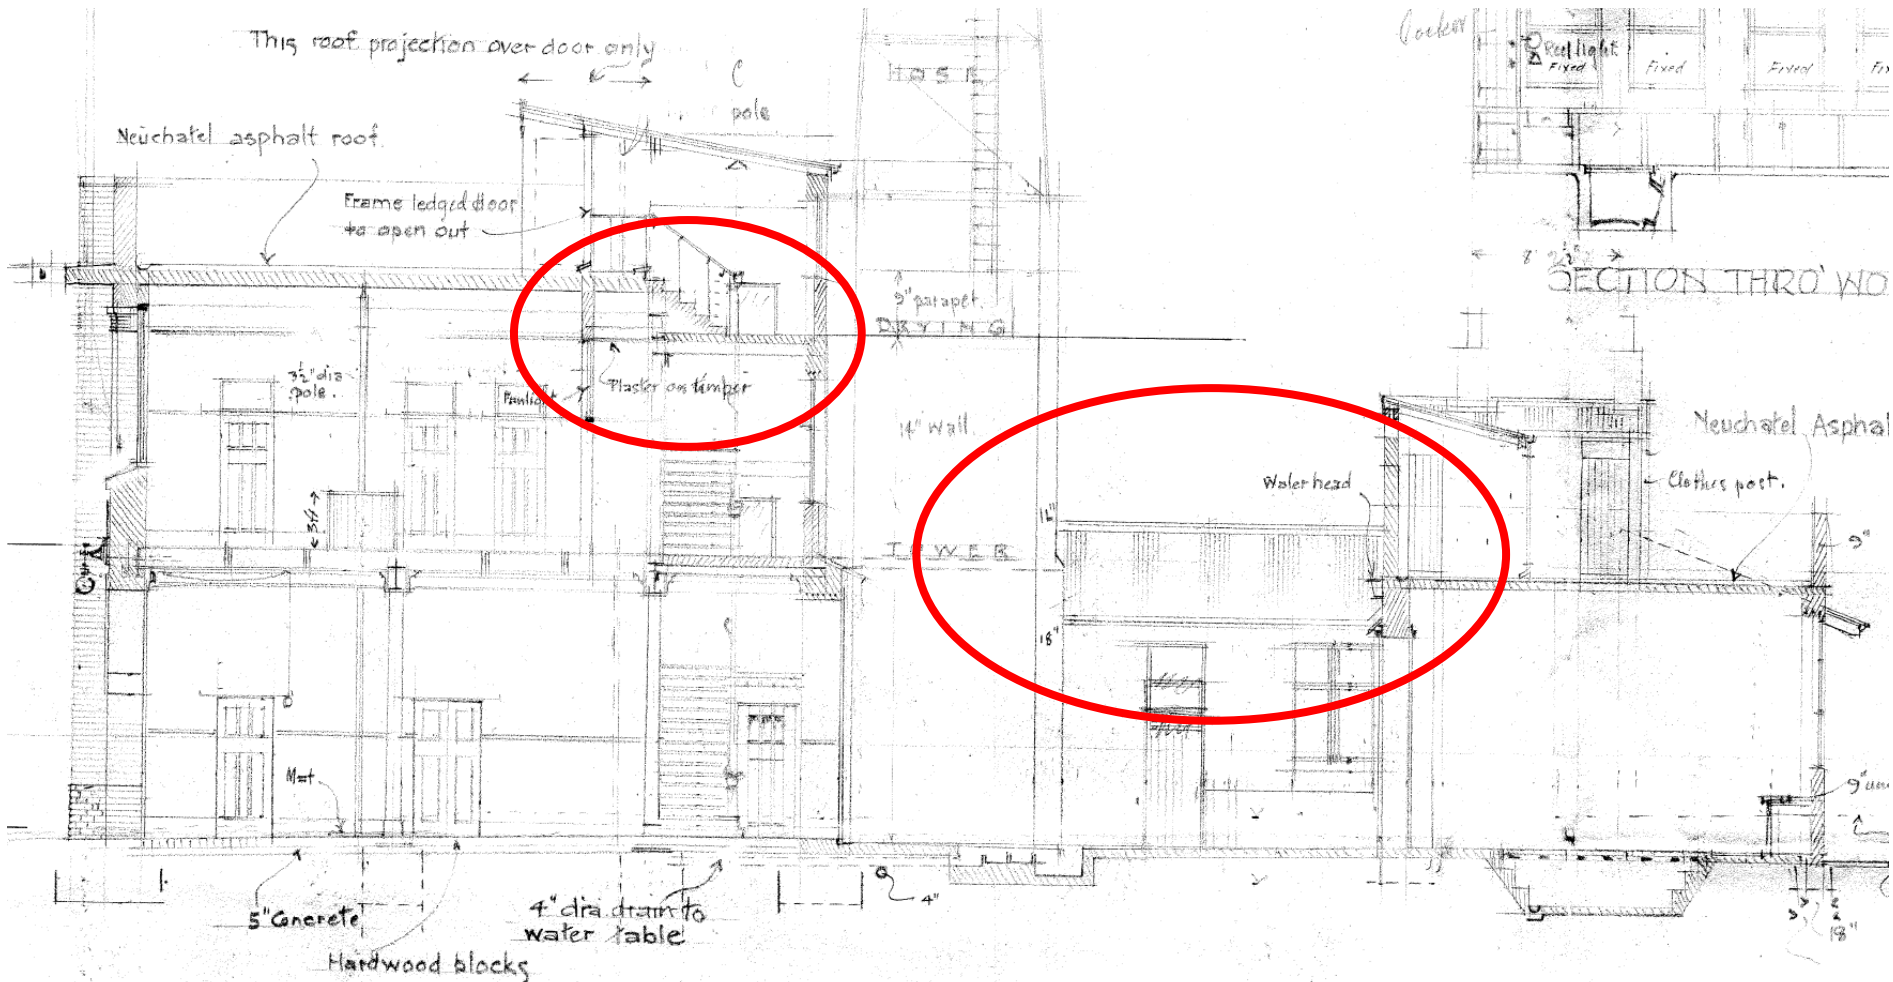
Plan irregularities (slightly more substantial)

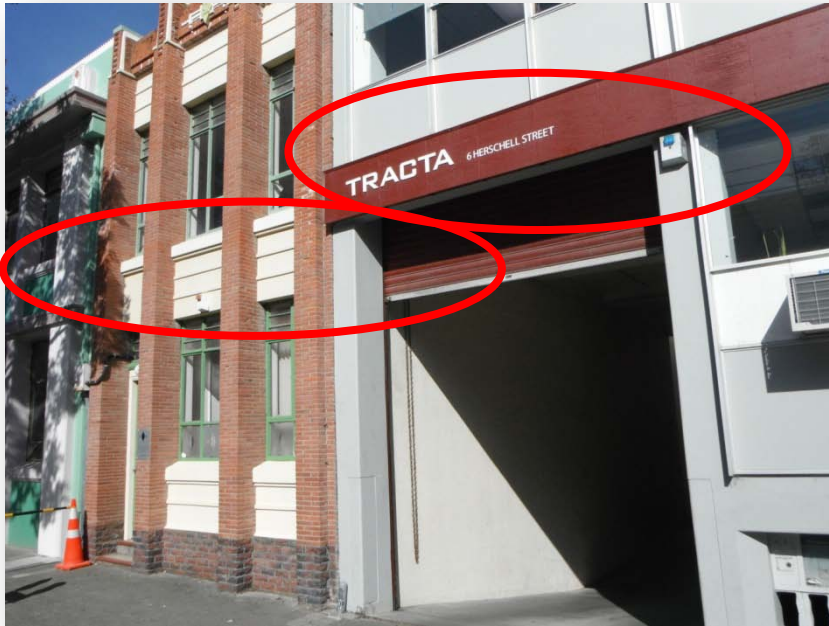
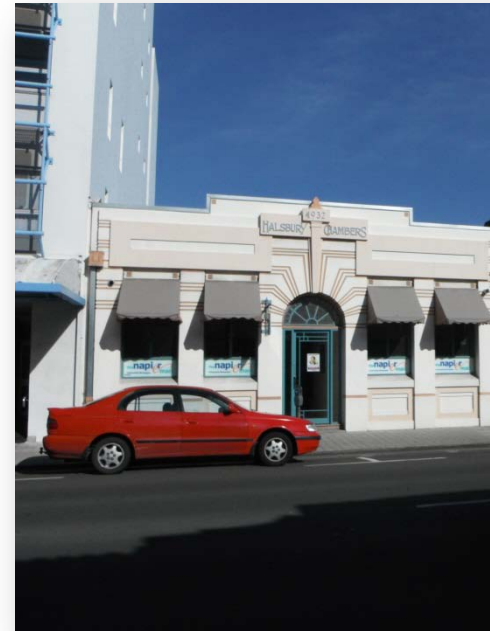
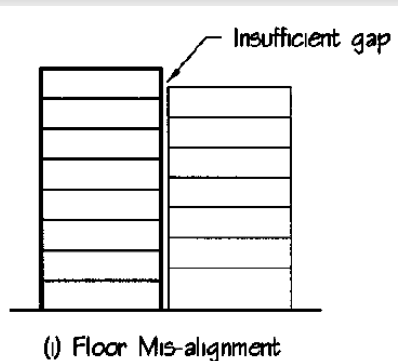
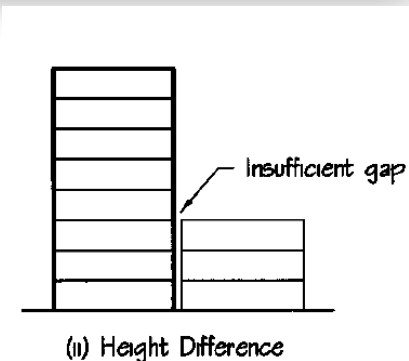
Pounding potential (significant in some locations)

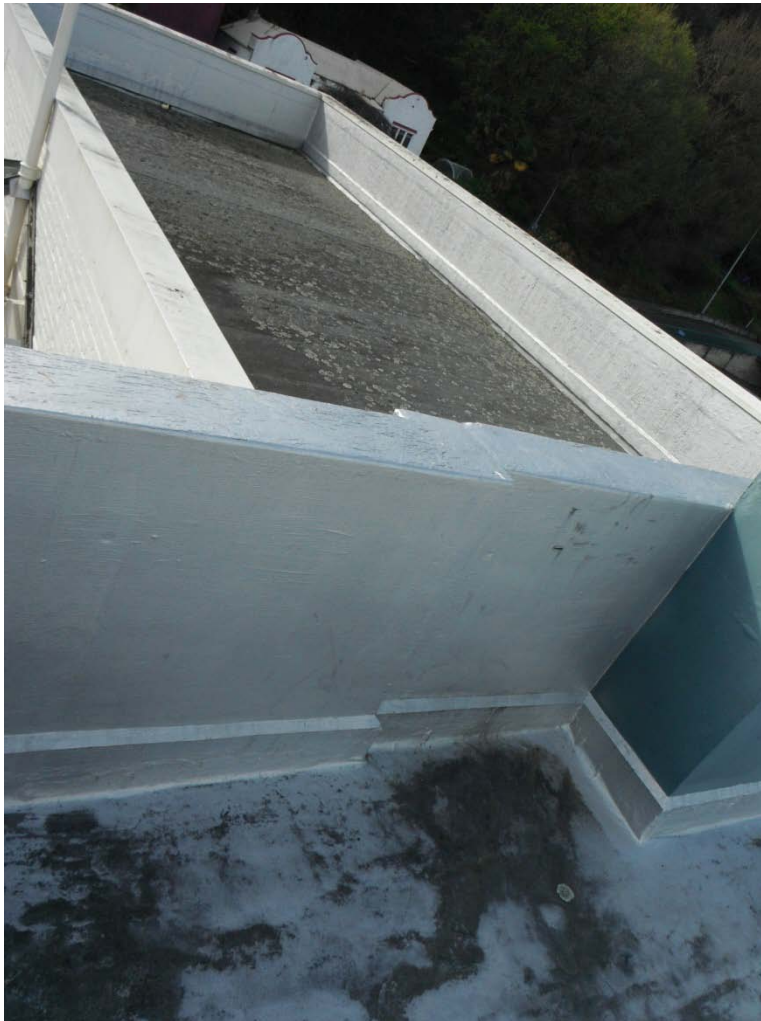
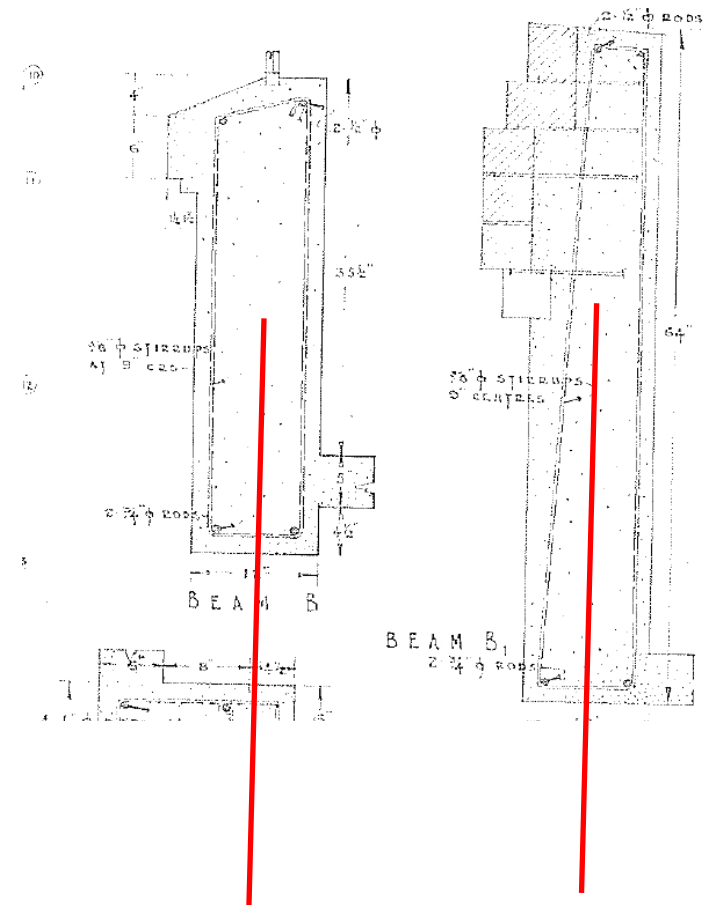
Reinforcement detailing (nominally ductile seismic design philosophy)

- One of JA Louis Hay's Buildings (fairly typical)
 - Longitudinal Column Steel
 - Provided: (4) ~ 3/4" Φ or (4) ~ 1" Dia. Rods = $0.012A_g$ - $0.016A_g$
 - NZS 3101 (2006):
 - $0.008A_g$, OK
 - Min. 8 Longitudinal Bars, Not OK
 - Column Confinement and Beam-Column Connection Transverse Reinf.
 - Provided: 3/8" Φ @ 8" = 203 mm
 - NZS 3101 (2006):
 - Max. spacing of $10d_b$ = 95 mm, Not OK
