# Performance of Retrofitted Singly Reinforced Concrete Walls Under Simulated Seismic Loading

Scott Minahan and Tobias Parsons

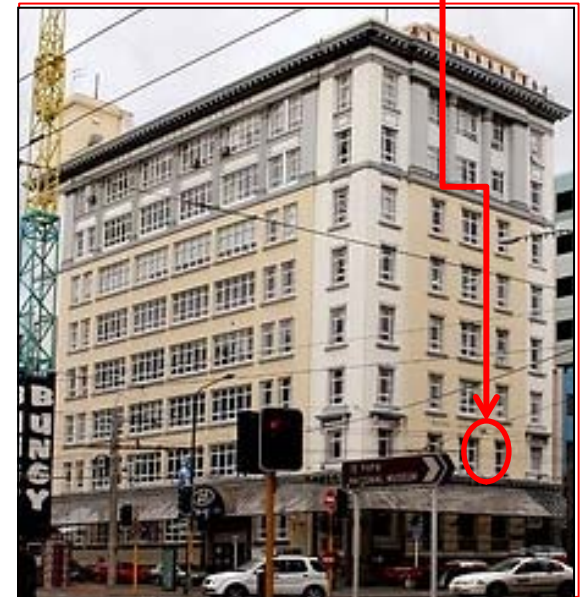
- The Hope Gibbons Building
  - Built in 1928 before EQ codes were introduced in New Zealand
  - Architectural and historical significance
  - Wall elements identified as a critical structural deficiency

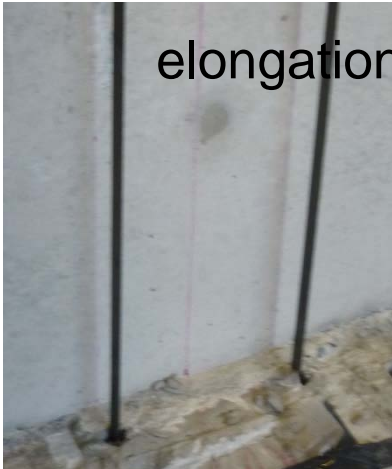
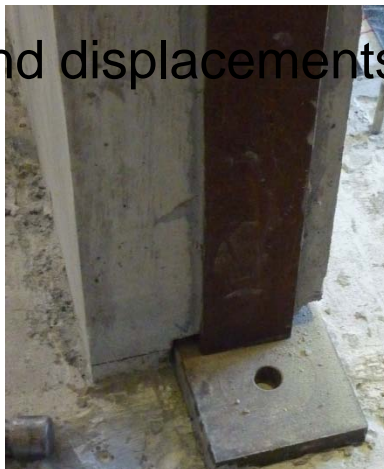
- SOLUTION 1- Steel T-section and CFRP strips
  - Isolated steel T-section:
    - » Provides high ratio compression reinforcement
    - » Do not provide tension reinforcement
  - 4 CFRP strips, external tension reinforcement

Un-bonded wall height:

- » High strains, elongations and displacements

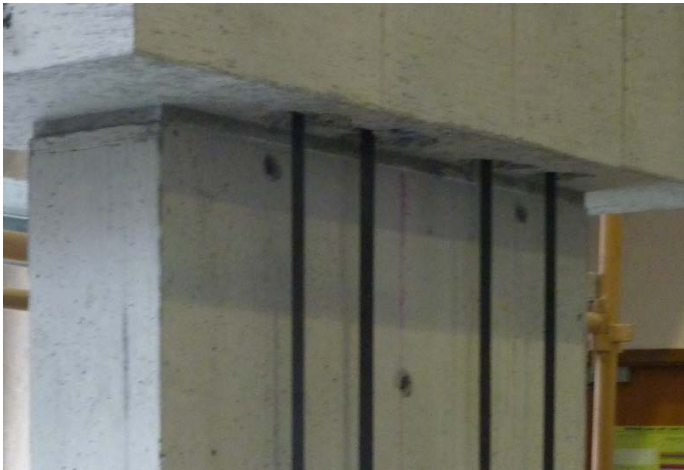
- SOLUTION 2: CFRP strips
  - » 8 CFRP strips, external tension reinforcement Un-bonded wall height:
    - » Provides high ratio tension reinforcement
    - » Achieves high strains, elongations and displacements

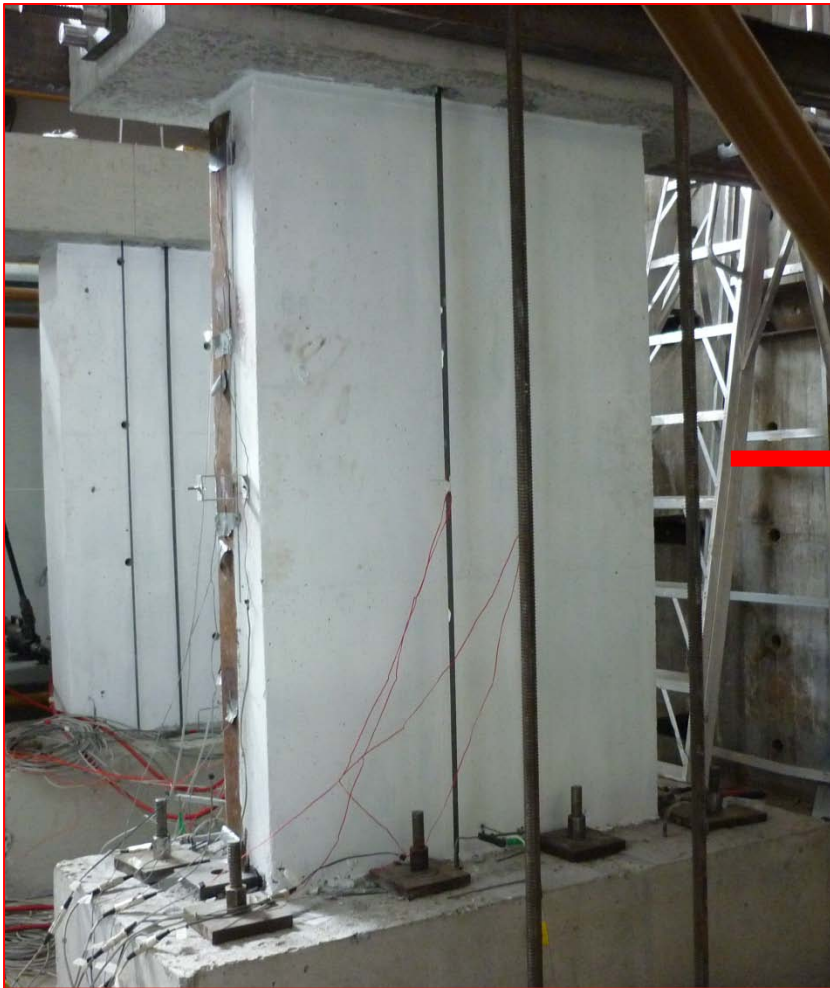
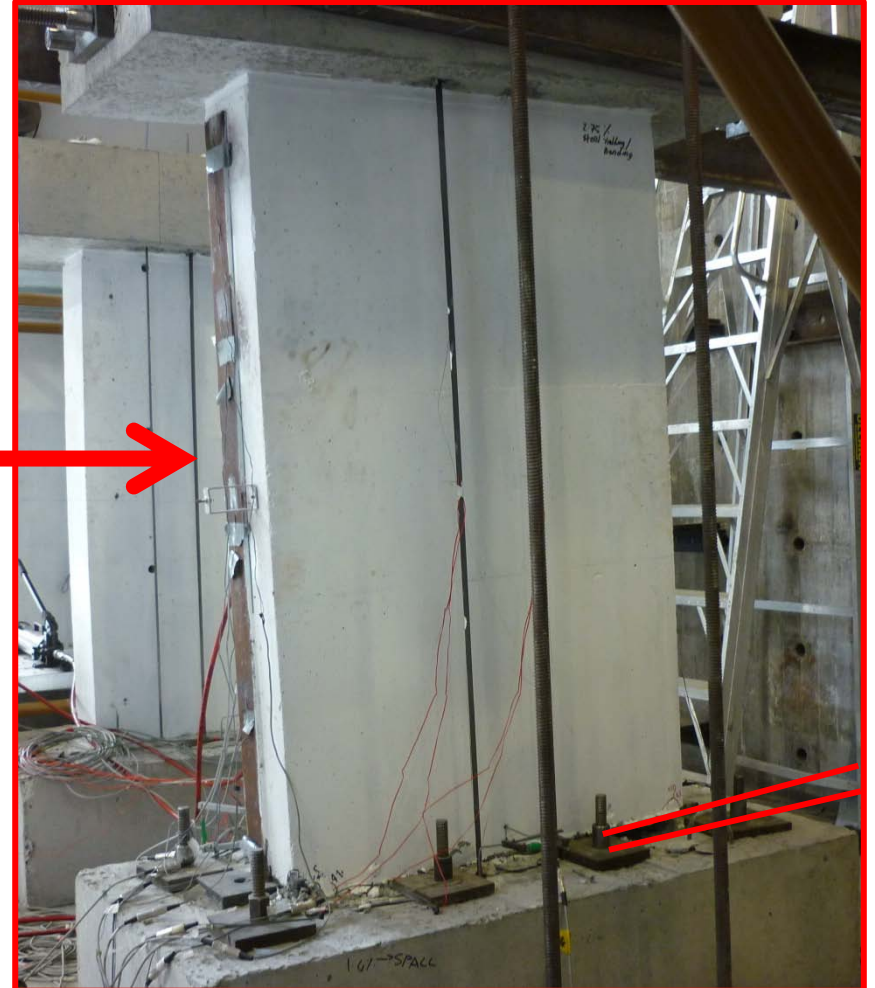
150mm specimens

- Greater energy dissipation in the retrofitted specimens
- Highest degradation observed in 150mm specimens

- All specimens maintained within 15% of peak strength to 5% drift
- Solution 1 specimens demonstrated a strength plateau
- Solution 2 specimens continued to gain strength before CFRP rupture
- CFRP rupture accompanied by sudden loss of strength

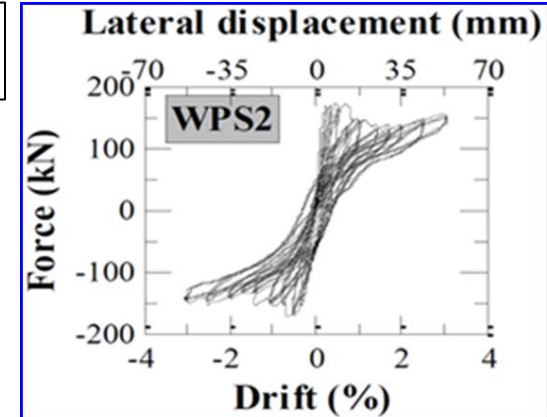
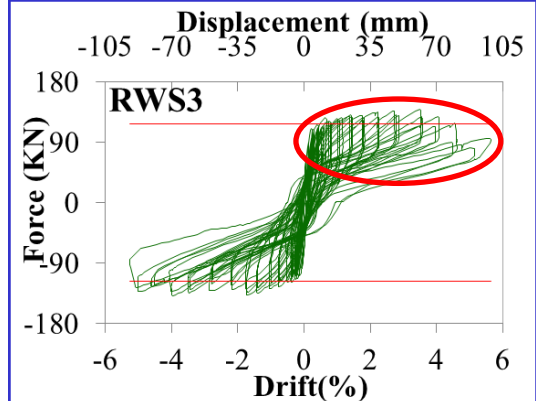
230mm specimens

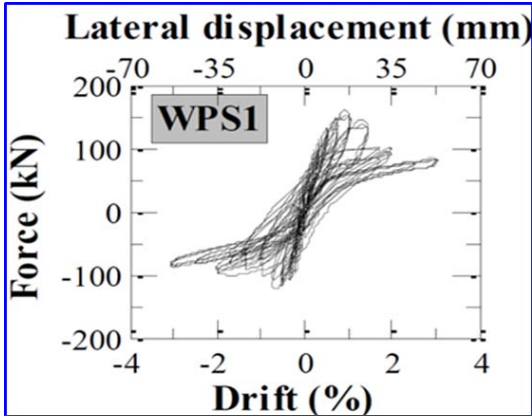
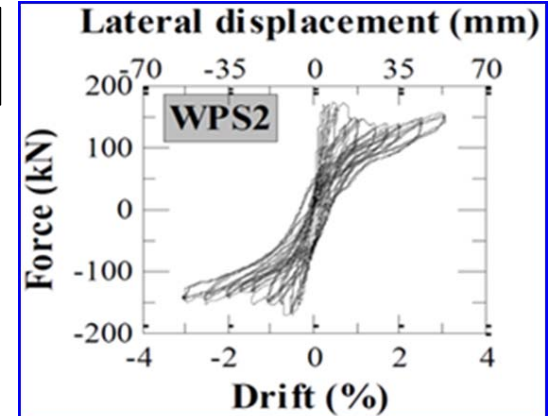
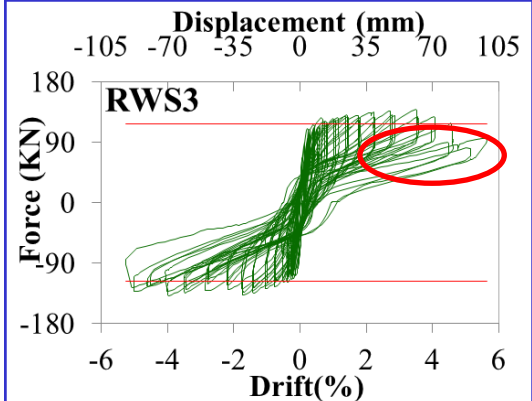
150mm specimens

230mm specimens

- Greater energy dissipation in the retrofitted specimens
- Highest degradation observed in 150mm specimens

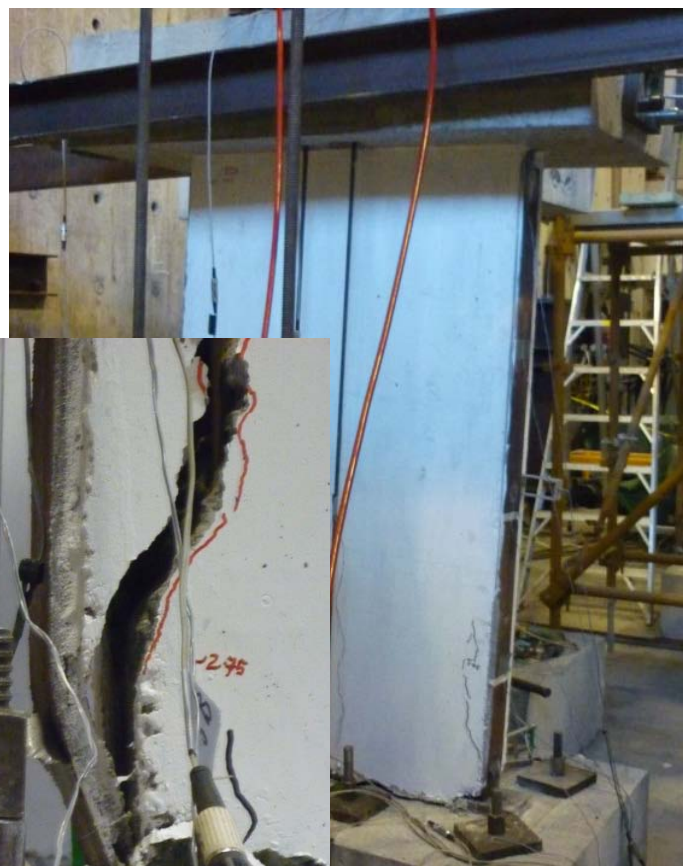
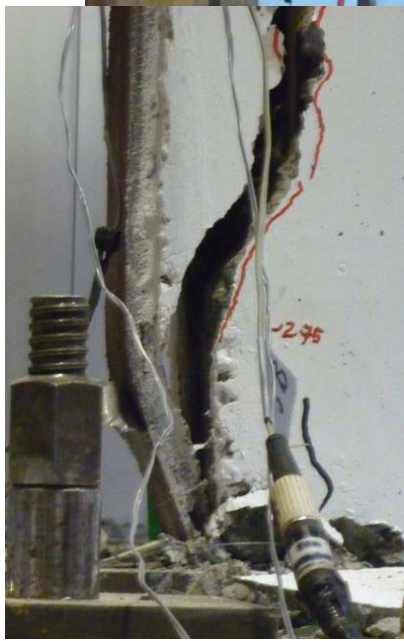
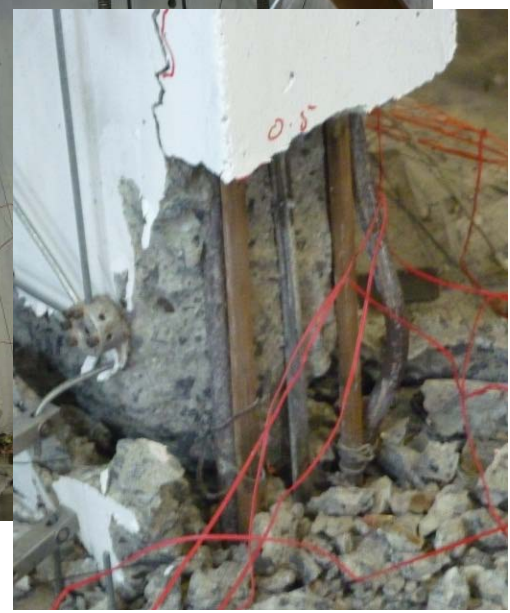
# RWS1 and RWS3

No rupture
