# **New Insights into Whole Building Performance from the Christchurch Natural Laboratory**

**Presentation to UACEER 2012 Earthquake Engineering Research Symposium, by G Charles Clifton**

**28 November 2012**

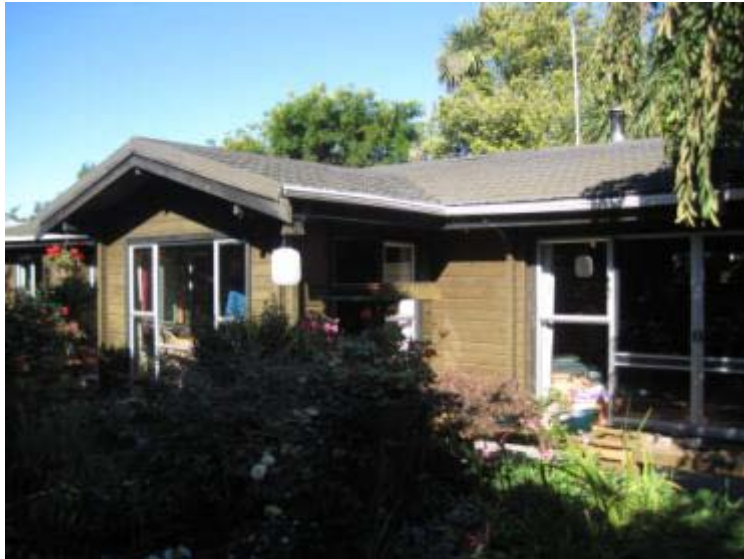
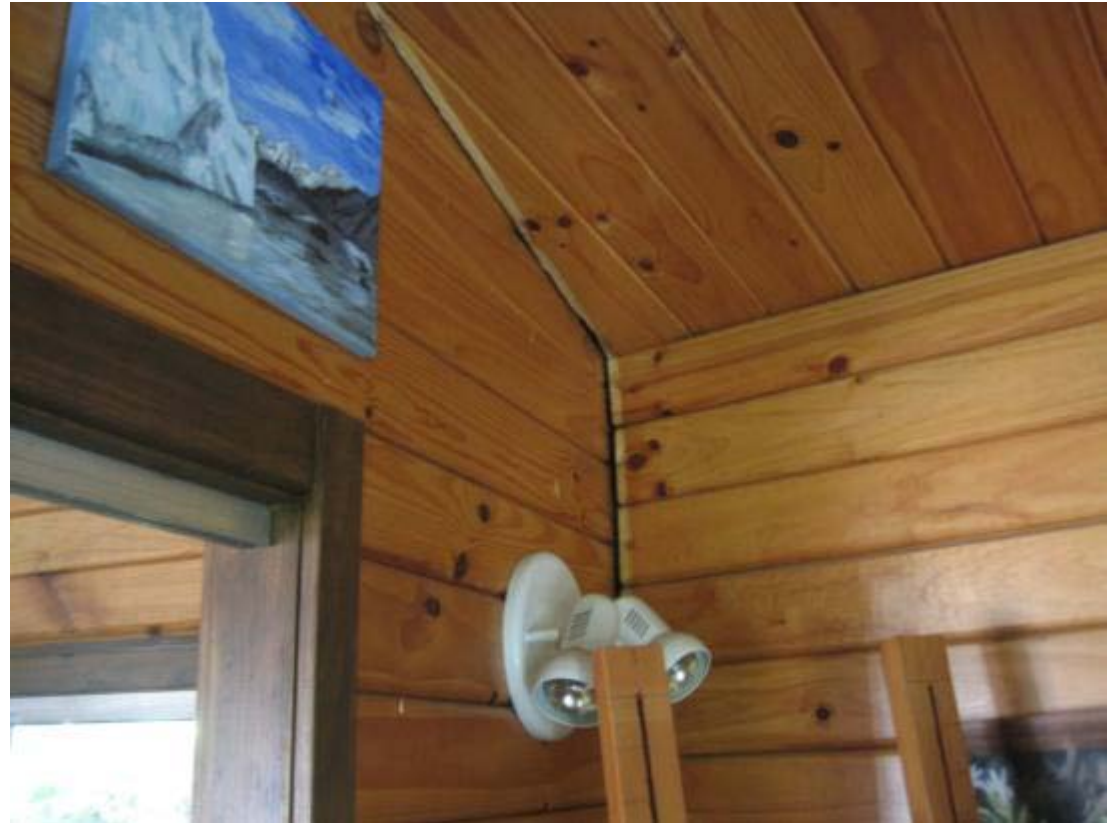
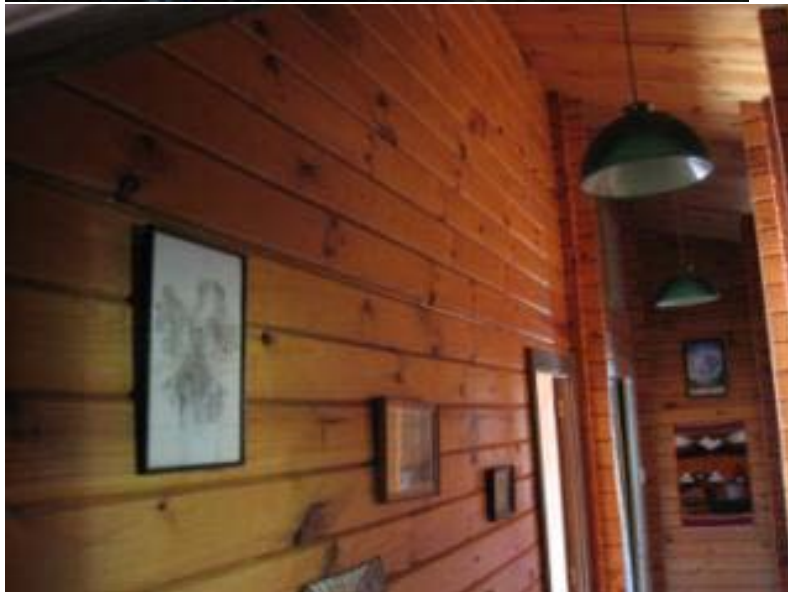
# Solid wood houses

Good performance despite  
differential slab movement

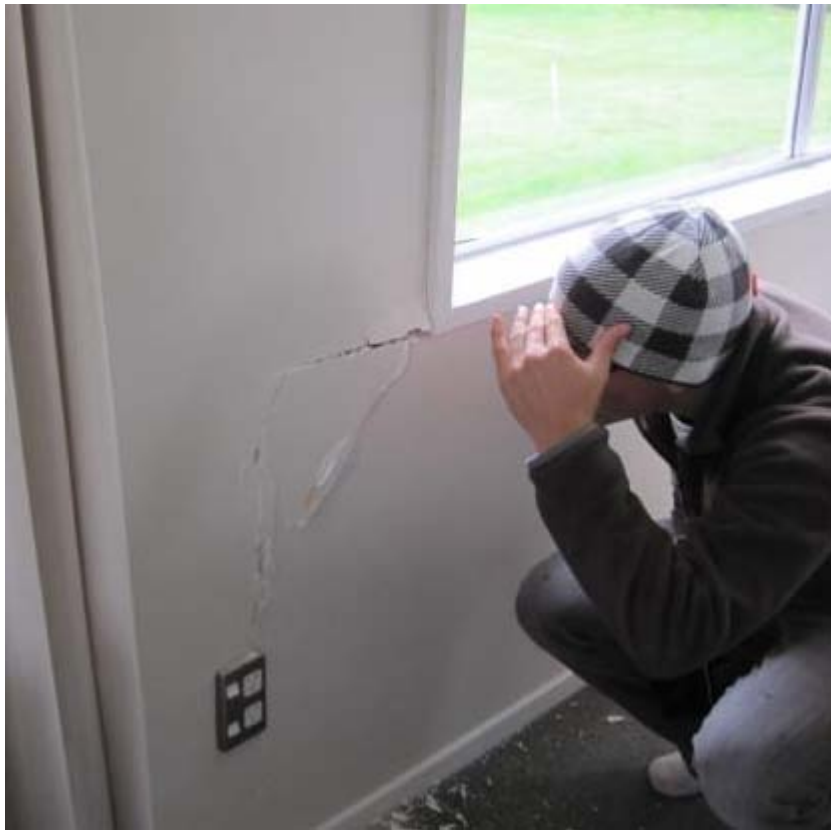
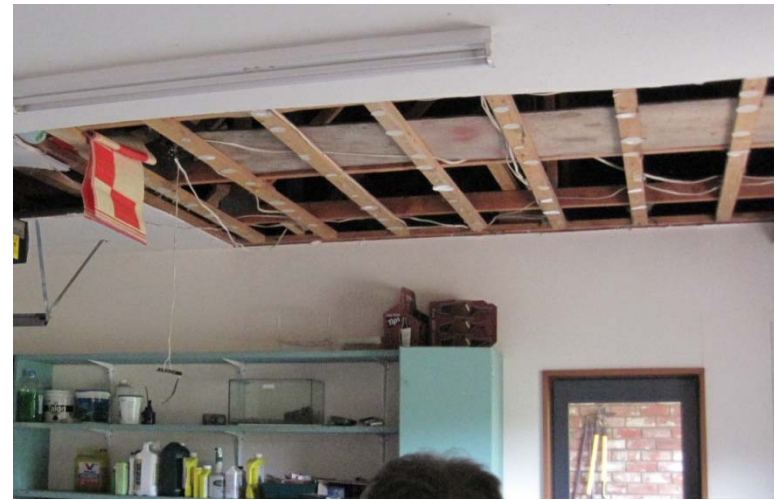
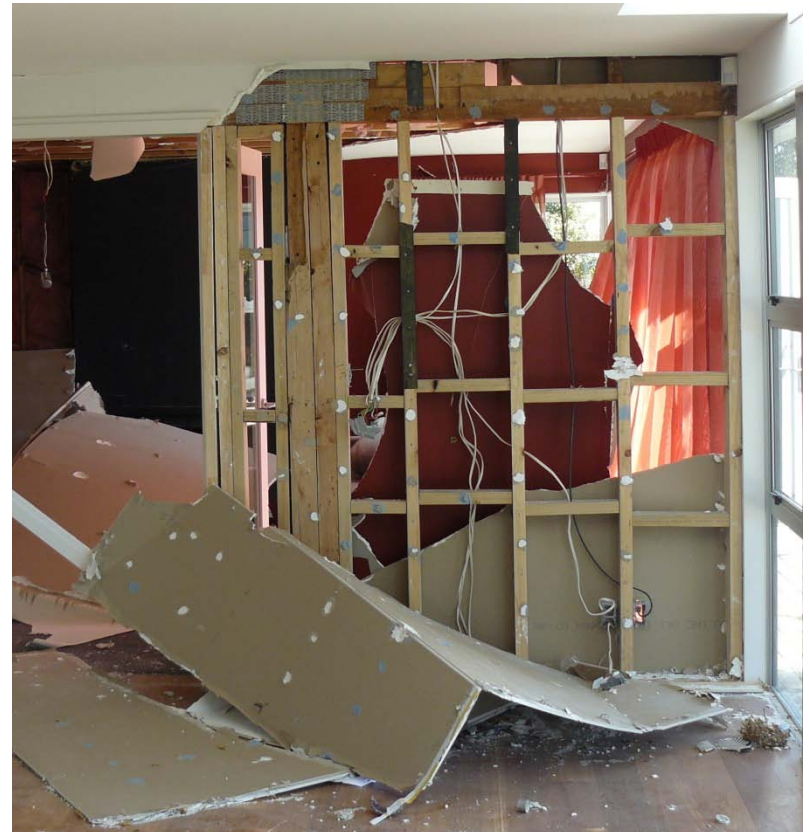
Provided bracing for most houses

Cracking and some dislodging

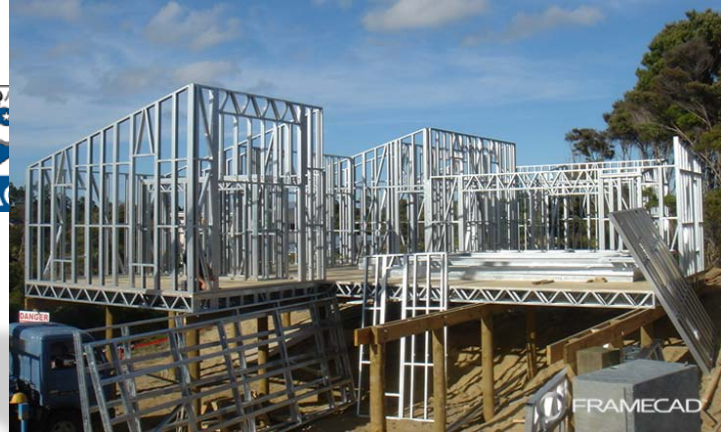
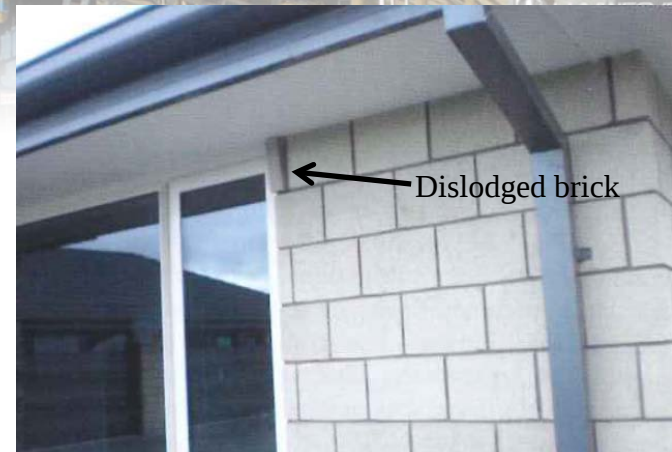
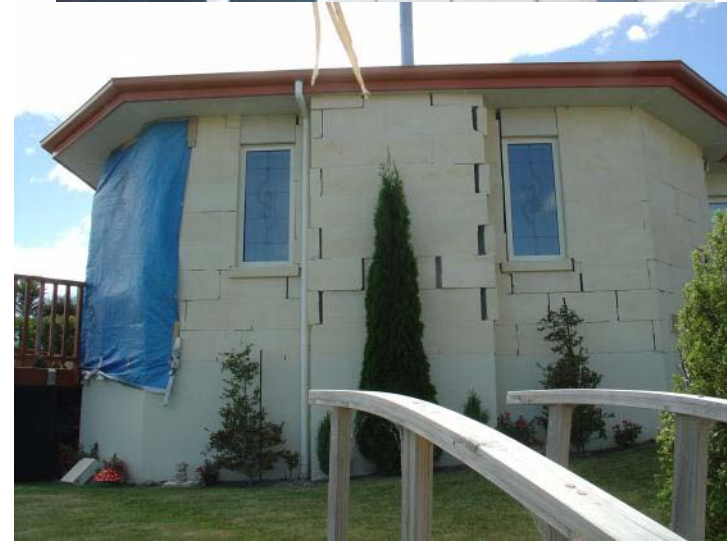
# Light Steel Framing: Excellent performance

- Around 50 houses in strongly shaken areas
- New construction (most within last 10 to 15 years)
- Typical LSF frame on concrete slab with brick veneer
- No to minimal damage on sites with good ground

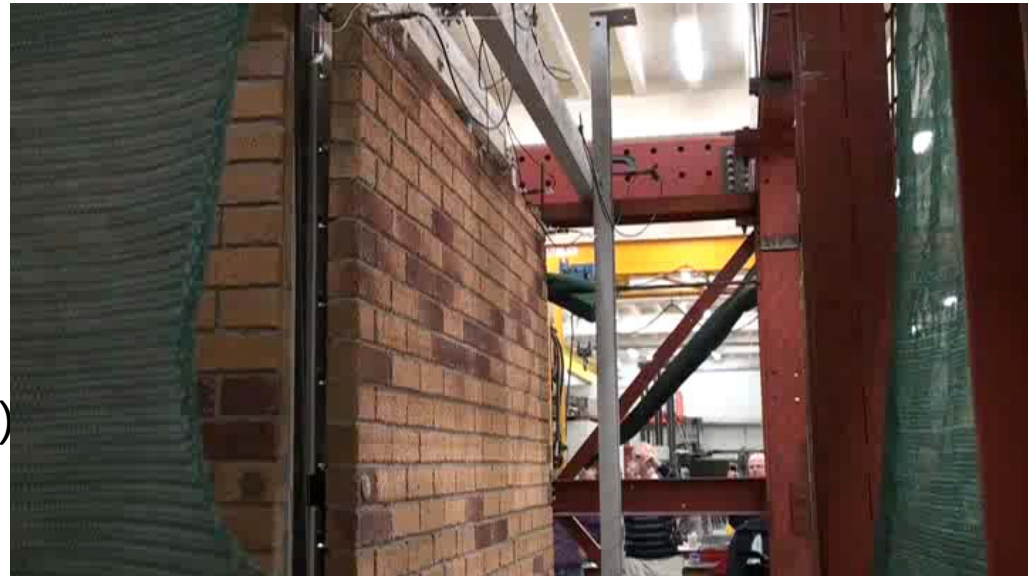
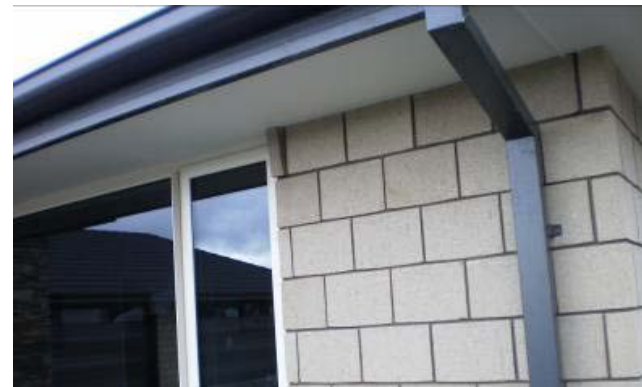
# Seismic Performance of Light Steel Framing With Brick Veneer

- Excellent performance observed from tests
  - no damage under SLS
  - hairline cracking under ULS
  - no loss of bricks at MCE
  - some brick loss at 1.6xMCE (2.7x El Centro or 0.95g PGA)
- Performance in Darfield earthquake consistent with these tests
  - minor cracking and few bricks loose worst damage
  - most houses show no damage including no damage at corners

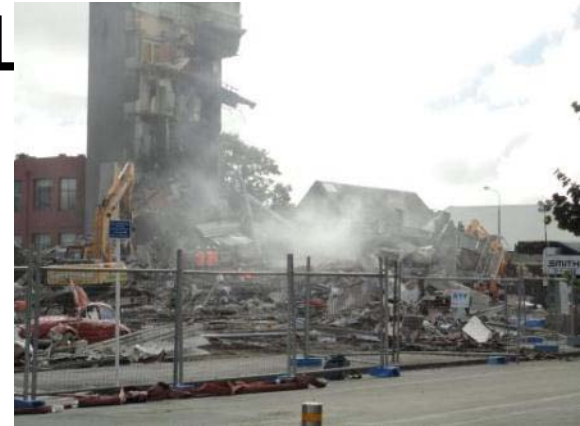
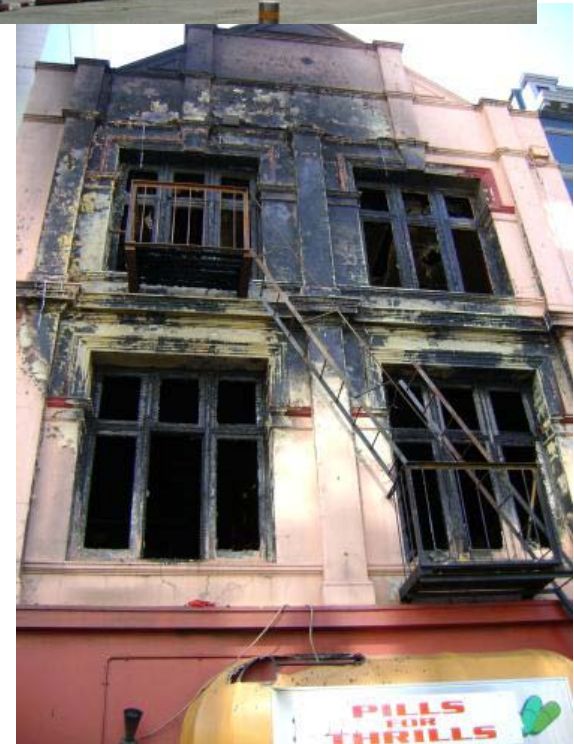
# Fire Following Earthquake: Christchurch 2010 and 2011

- Only 1 fire in each of the two biggest earthquakes
- 22 Feb occurred at worst possible time for fire to occur
  - many parts of city similar construction to Napier and greater damage, but no fire
- Gas and electricity cut-off systems worked very well
- Sprinkler systems did not discharge due to earthquake
