Seismic Assessment and Improvement of Napier's Art Deco Buildings

UACEER 2012 Earthquake Engineering Research Symposium

Kevin Walsh and
Jason Ingham

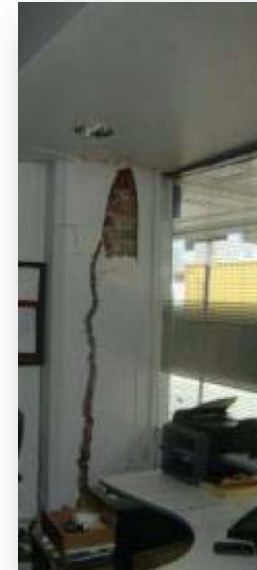
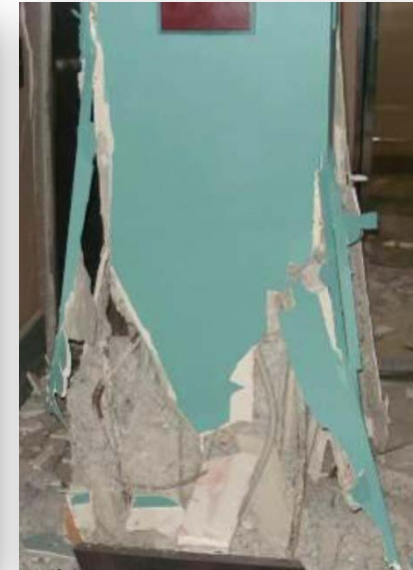
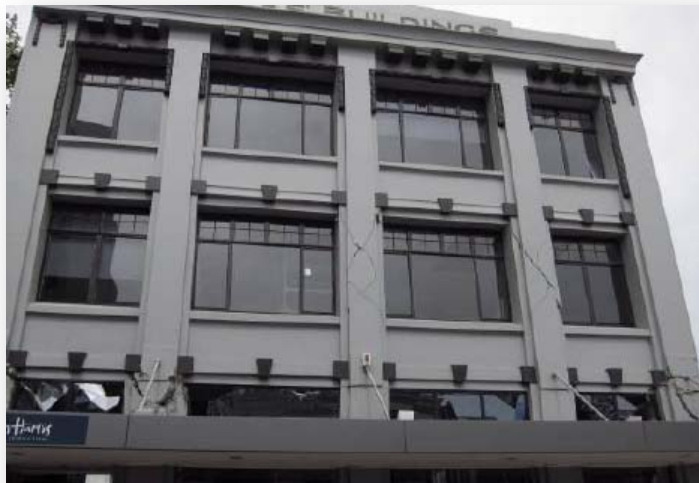
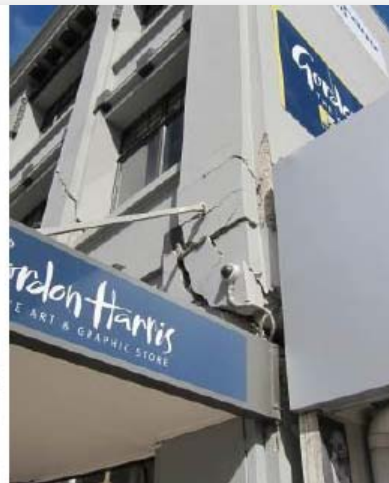
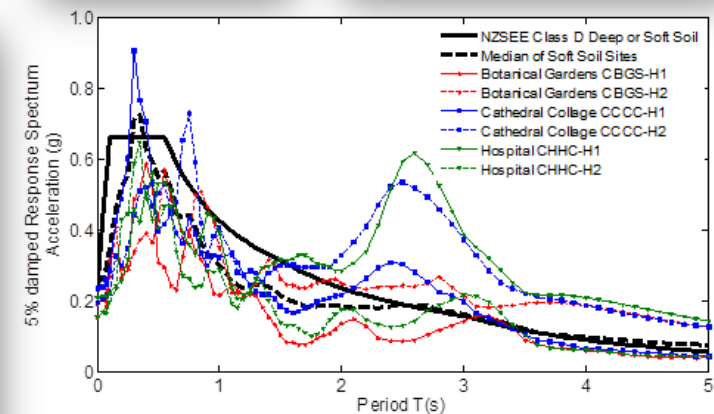
(Photos from W.Y. Kam, U. of Canterbury)

- 10 similar buildings considered
 - RC frames, some with brick infill walls
 - built 1920-1940
 - 2-4 storeys
- 4 very similar in size & style

- Inadequate reinforcement detailing in general providing little ductility
- Poor concrete material properties
- Irregular plan and elevation configurations, torsional effects
- Shear cracking in exterior columns
- None of 10 buildings here experienced complete collapse, despite unusually high EQ intensity and unique vertical motions
 - partial collapse of URM infill wall experienced
