In-situ testing of Unreinforced Masonry Building in Whanganui

Dmytro Dizhur

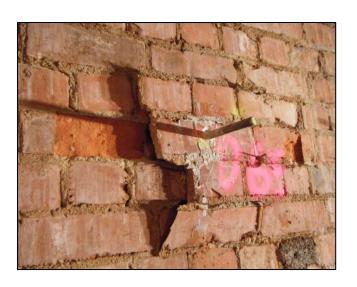
Part 1a - Anchoring Connections

- Anchor type
 - Epoxy and grout
 - Mechanical
 - Through bolts
- Orientation
 - Straight and bent
- Embedment depths
 - 100, 200, 300, 400 mm
- Rod diameters
 - M12, M16, M20
- Overburden weights
 - Ground floor, first floor and parapets

~400 tests conducted

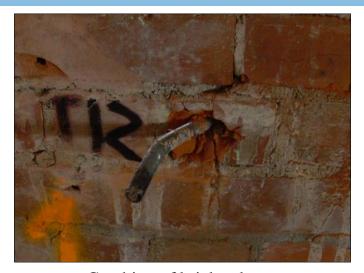
Part 2 – Shear transfer connections

- Data not available in literature
- Failure modes
 - Double shear of anchor
 - Timber crashing

Crushing of brick substrate

Crushing of timber

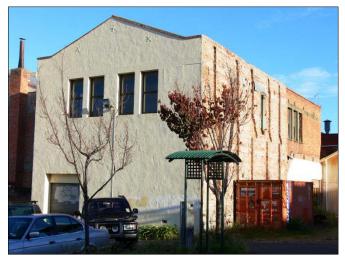
35 Drews Avenue, Whanganui

- Built 1913
- Lime mortar and clay brick masonry
- Two stories
- Original flexible timber diaphragms
- Derelict for >5 years
- Up for demolition
